CONCLUSIONS AND SUGGESTIONS AFTER EEP-VCF STAFF VISIT AT THE PARCO NATURA VIVA

The Bearded vulture aviary:

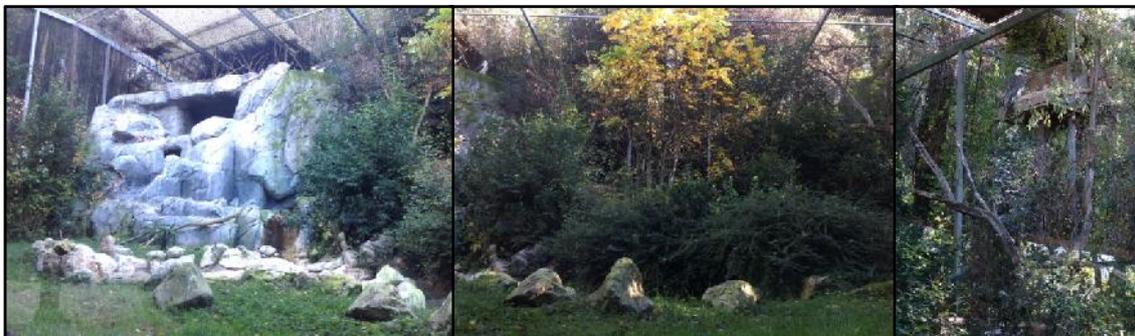
Is a huge aviary with three defined parts. At the left a cliff with two caves (a smaller one in the lower part and a big one in the middle part -about 2 m high-) and at the top a ledge with the backside closed with mesh and branches and with a transparent PVC roof. At the right a small nest platform with the same kind of roof, closed to the black stork aviary. In the middle, a small waterfall with three troughs (the last one is very deep and with a step banks). The entire aviary is full with vegetation and only a small green corridor exists between the trough and the visitors' observation point. The observation point is wood made with a roof and several windows where the public can have a look at the birds.

Left side

middle part

right side

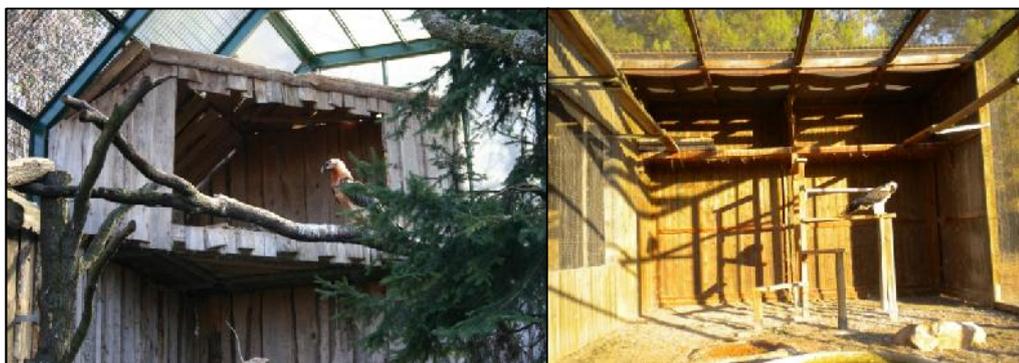
- Build in the right side corner a **new platform/cave with a nest** (2.5-3 m width x 1.5 m deep and 1.2 m high) and protect the view from the neighbour black stork aviary building e.g. a **wooden wall** with the same altitude size like the nest cave (1.2-1.5 m) in the sidewall.

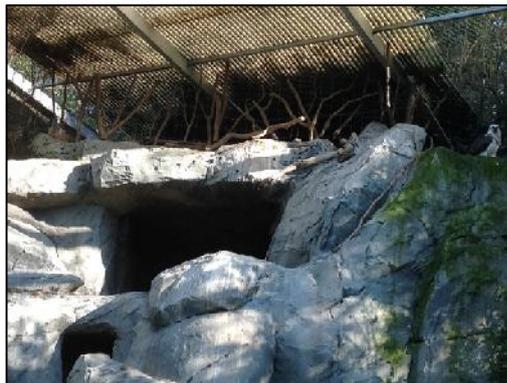
- The cave in the middle of the cliff is too big. Better **build a second nest on the top from the cliff**, removing the mesh with the branches. Is the higher part of the aviary and far away from the visitors observing point. The birds will feel more secure there.

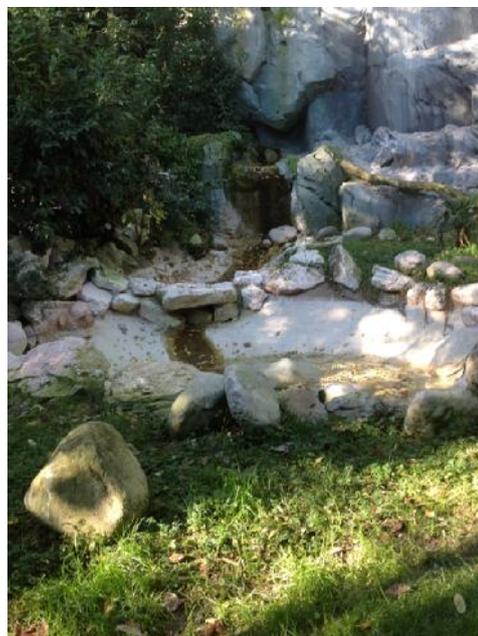
- None of the three water troughs are adequate for bathing. The first two ones have no deepness and the last one is so big and with such a step banks, that the birds have no possibility to take a bath. The best solution is **adequate the second water trough** for bath. By the water runoff make it 35-40 cm deep and at the water entry do it with a smooth entry.
- The green surface between the **big trough** and the wall is very narrow, with not enough landing place. A good solution could be **filling it with earth** and remove all the stones increasing considerably the green surface.

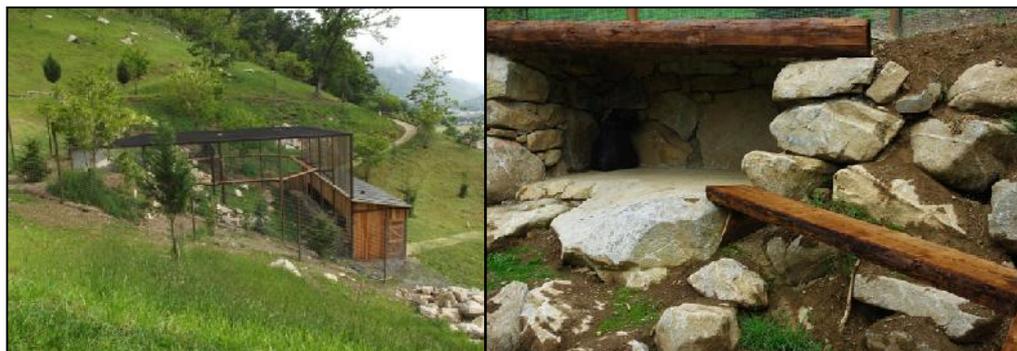
- The aviary is very big bad the birds cannot use all his potential. They have only two roost places on the top: the right nest and the ledge over the cliff. The **installation of perches around the cage** (minimum 20cm width and 5 cm thick), give them the possibility to move around the cage without getting off the ground, especially when the nest must be controlled by the keepers.
