CONCLUSIONS AND SUGGESTIONS AFTER EEP-VCF STAFF VISIT AT THE PLOCK ZOO

Following the proposal from the EEP to transfer the alone staying Bearded Vulture female from Plock Zoo to Richard Faust Breeding Center, for pairing with an adult male, it was accorded between Plock Zoo and EEP/VCF to take advantage of the moment of the female transfer, to invite Alex Llopis and Hans Frey to visit the Zoo, and have a look at the Bearded Vulture installation.

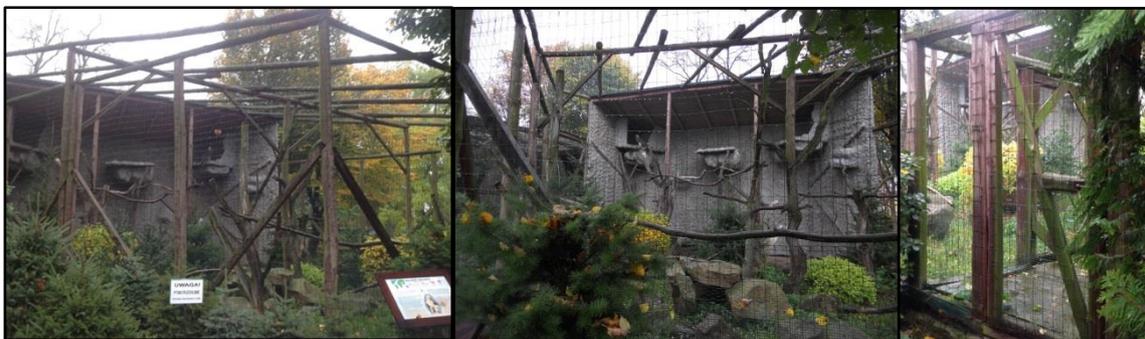
The Bearded Vulture aviary has an optimal size for housing a breeding pair, big enough for giving the birds the necessary escape distance from the visitors and not too big preventing to obtain a dangerous flight speed. The aviary is made of wood (picture 1) and the back wall is made of concrete with a nest in each corner: on the right an open nest and on the left a cave (picture 2). Outside it is surrounded with vegetation, giving the birds the necessary tranquillity to reproduce, because the visitors have only access/view from the front side.

The entrance to the aviary is visible to the birds and far away from the nest. The aviary has a security cabin with a double door system to prevent birds from escaping (picture 3).

Picture 1-3: The Bearded Vulture facility is a wooden aviary with a concrete back wall which includes a nest-platform at each corner. The entrance has a security cabin and is far away from the nest.

The aviary has reinforcement structures inside the aviary (picture 1, 2).

- **Remove the reinforcement structures inside of the aviary** which could lead to collisions.

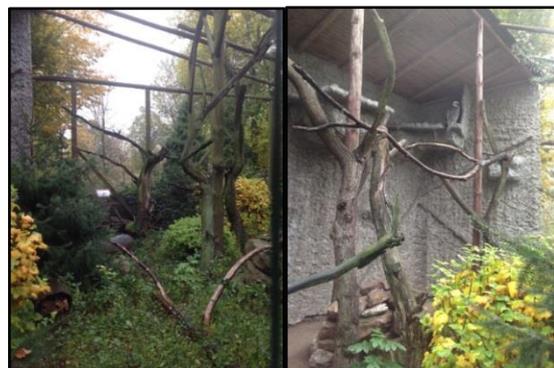
Picture 4-5

At the back wall there are three steps for climbing up to the nest. The aviary is full of vegetation (picture 4), stones and branches - with a diameter around 8-12cm - as perches across the aviary (picture 5) which prevent to fly and land without danger. Near the back wall there is a plastic drinking bowl.

- To prevent injuries caused by collisions, **almost all of the vegetation inside the aviary** should be **removed**. These are obstacles that by other facilities have already caused the loss of several individuals. There is the possible to remain 1-2 small bushes.

- To prevent accidents by landing it is important to offer open and clean ground. **Remove most of the stones** on the ground. 1-2 bigger ones can be used as feeding place.

- **Remove the branches which are installed as perches.** As Bearded Vultures are cliff breeders, perches need to be adapted to suit the anatomy of their feet. They should be **flat, around 20cm wide, 4-5cm thick** and also need to be **rigid enough** to prevent them from bending during copulation on the perch. It is recommended to install a **holding arm perches system which avoids collisions** with it.

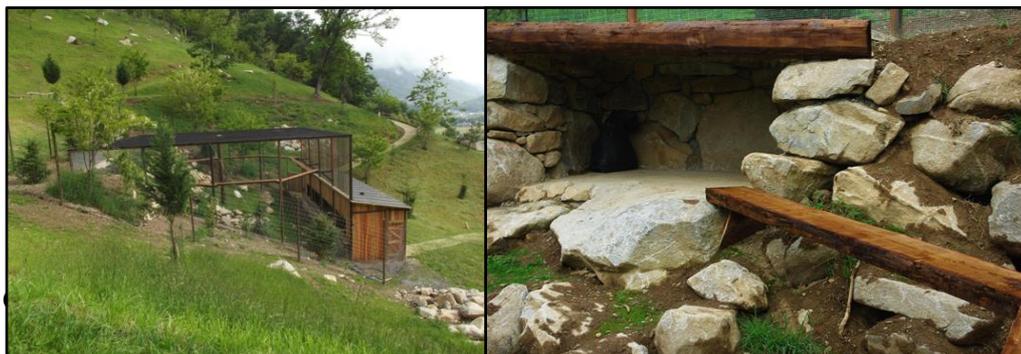
Install perches around the aviary (60cm away from the mesh and never higher than the nest). This gives them the possibility to move around the cage without getting on the ground, especially when the nest must be controlled by the keepers.

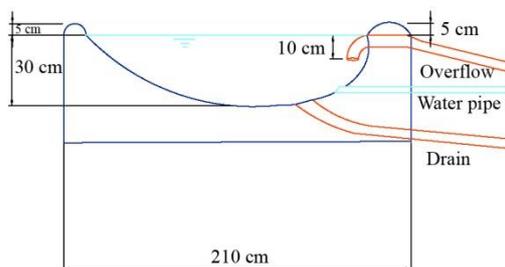
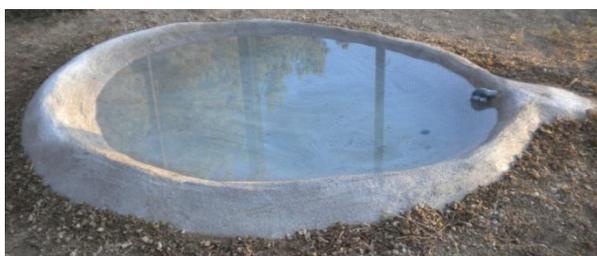
- It is recommended to avoid to enter and cross the cage for feeding the birds. **Remember** their cage = their territory. Like in the wild, if you approach their territory the pair feels threatened and leaves the nest. **Install a 90 x 90cm feeding place close to the security cabin** where food can be deposited by only opening the door, without entering in the aviary.
- All birds of prey drink and bath regularly. And especially during egg formation, females drink large quantities of water. **Install a drinking bowl** in the middle of the aviary. This should have a soft access ramp and be big enough to allow the birds to bathe (210 x 130cm wide and 30-35cm deep). **A mechanism that allows the drinking bowl to be regulated from outside the aviary**, avoids any disturbances by entering in the aviary during the breeding season.

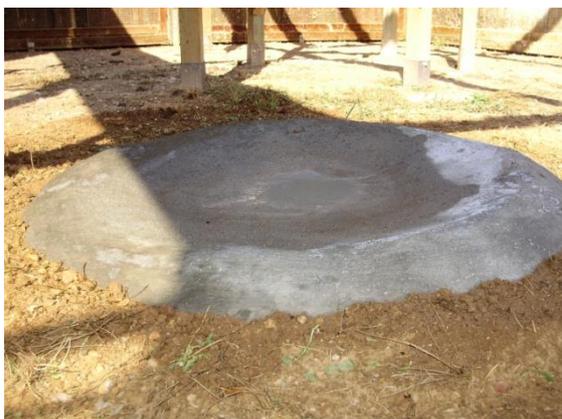
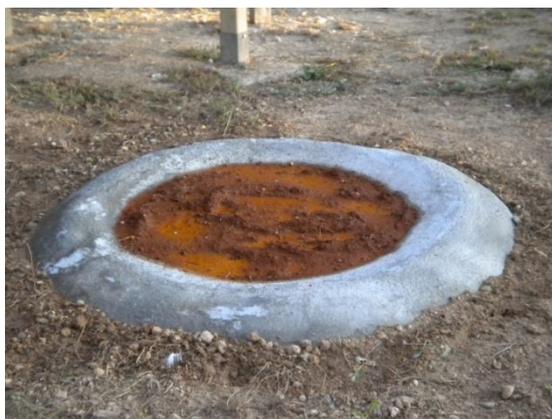
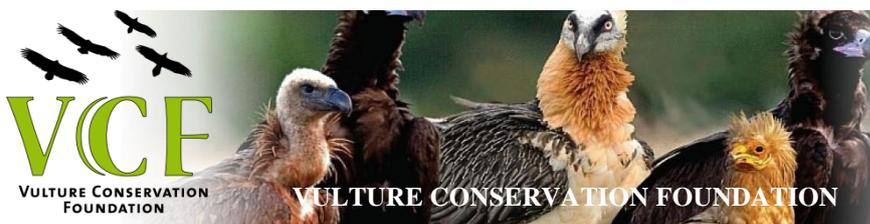
- Bearded Vultures develop the peculiar habit of bathing in mud rich in iron oxide. Although the reason for this behaviour is still unknown, they must be kept in captivity in good physical and psychological condition, offering them all available means of developing as many innate behavioural patterns as possible. Therefore it is recommended to **install a mud bath** where mud rich in iron oxide can be provided every 15 days (1m in diameter, and 10cm deep). Use only mud **free of any toxic substances** (heavy metals or other organic contaminants).
